**Flood Control Project Maintenance
Levee Inspections**

Maintenance Issue Types Only, Levee Inspection Report By Mile - Fall 2016

Reclamation District No. 0150 Merrit Island

Waterway	Bank	Unit Miles	Inspection Start/End	Inspector
Unit No. 01 Sutter Slough	Left	0.52	11/01/2016 11/01/2016	Pavel Kazi

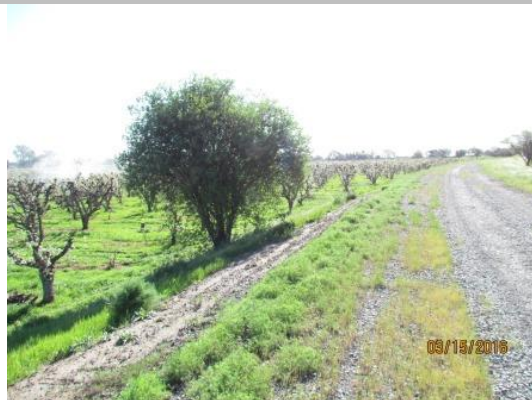
Photo 1 of 1 : FA_2016_RD0150_15_3_20160823_00003.jpg

LM Start	0.19	Rating **	A/W	Issue No.	3
LM End	0.19	Issue Type +	Ma	Location *	LS
Category	Earthen Levee			GPS Latitude/Longitude	
				Start	End
Item	Vegetation			38.331402°	38.331402°
				-121.580358°	-121.580358°
DWR ID	DWR_RD0150_01_s_2012_3				
Comment Code					
V4 : Elderberries are blocking visibility and flood fight capability.					
Inspector Comment					
Elderberry is trimmed and levee slope is accessible.

View of the elderberry on the landside toe of the levee. The elderberry doesn't block visibility and it is trimmed up 5 feet above the slope.

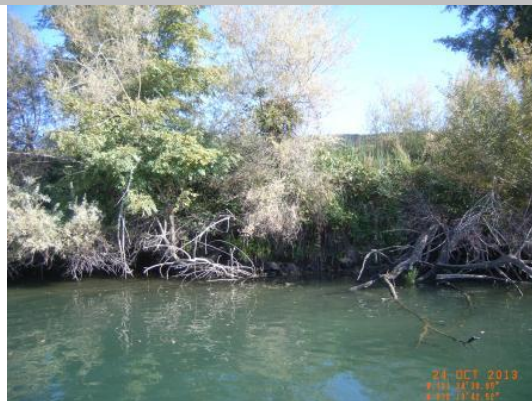
Photo 1 of 2 : FA_2016_RD0150_15_2_20160823_00001.jpg

LM Start	0.44	Rating **	M	Issue No.	2
LM End	0.49	Issue Type +	Ma	Location *	WS
Category	Supplemental			GPS Latitude/Longitude	
				Start	End
Item	2015 USACE Erosion Survey, DRAFT			38.328555 °	38.328020 °
				-121.577544 °	-121.576693 °
DWR ID	DWR_RD0150_01_s_2016_2				
Comment Code					
Inspector Comment					
2013 - Old toe repair unraveling. Bridge at upstream end of site. 2015: No observed changes. [2015 Site ID: STR_28-4_R]

USACE 2013 Photo #1

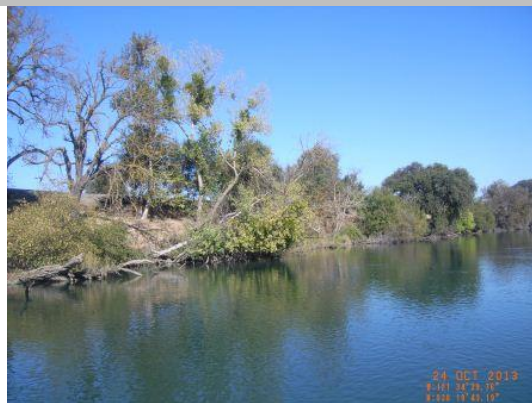
Photo 2 of 2 : FA_2016_RD0150_15_2_20160823_00002.jpg

USACE 2013 Photo #2

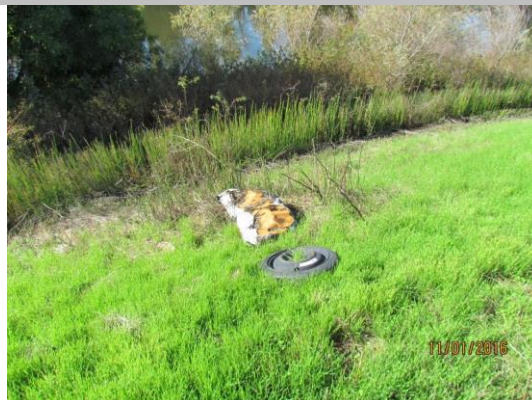
Photo 1 of 1 : FA_2016_RD0150_15_7_20161104_00005.jpg

LM Start	0.49	Rating **	M	Issue No.	7
LM End	0.49	Issue Type +	Ma	Location *	WS
Category	Earthen Levee			GPS Latitude/Longitude	
				Start	End
Item	Encroachments			38.328256 °	38.328256 °
				-121.576637 °	-121.576637 °
DWR ID	DWR_RD0150_01_f_2016_7				
Comment Code					
DE : Debris					
Inspector Comment

View of debris on the waterside slope of the levee. Fall 2016

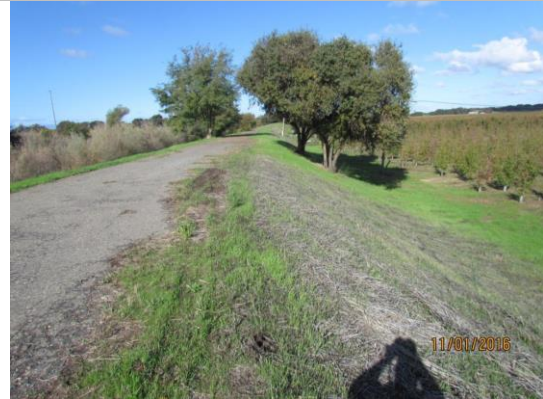
Photo 1 of 1 : FA_2016_RD0150_15_1_20161104_00004.jpg

View of the landside slope of the levee. Fall 2016

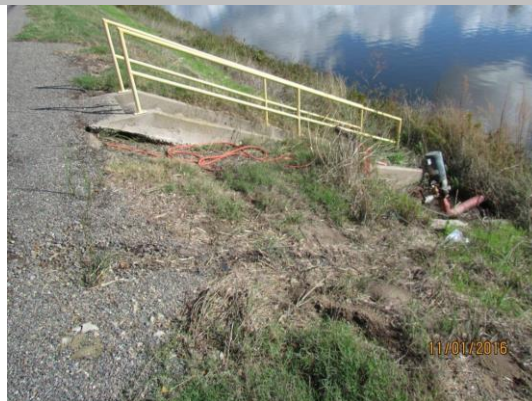
Photo 1 of 2 : FA_2016_RD0150_16_6_20161104_00118.jpg

LM Start	0.38	Rating **	M	Issue No.	6
LM End	0.38	Issue Type +	Ma	Location *	WS
Category	Earthen Levee			GPS Latitude/Longitude	
				Start	End
Item	Slope Stability			38.332598°	38.332598°
				-121.572179°	-121.572179°
DWR ID	DWR_RD0150_02_s_2012_6				
Comment Code					
S2 : Repair the levee slope damaged by foot traffic and prevent access where possible.					
Inspector Comment

Updated view of the slope instability on the waterside of the levee. Fall 2016

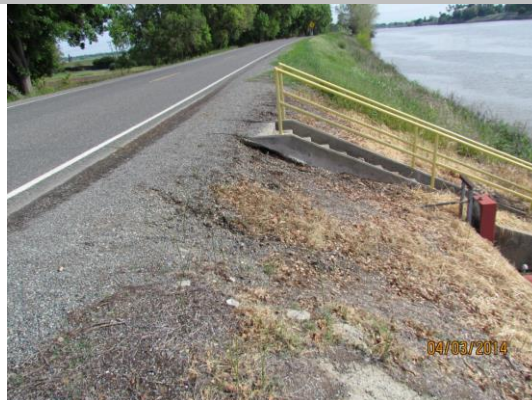
Photo 2 of 2 : FA_2016_RD0150_16_6_20160823_00003.jpg

Updated photo of the slope instability on the waterside of the levee looking upstream during spring 2014 inspection.

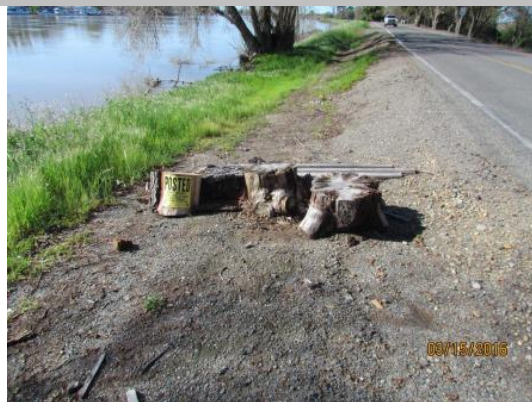
Photo 1 of 1 : FA_2016_RD0150_16_57_20160823_00032.jpg

View of tree stumps on the waterside shoulder of the levee looking downstream.

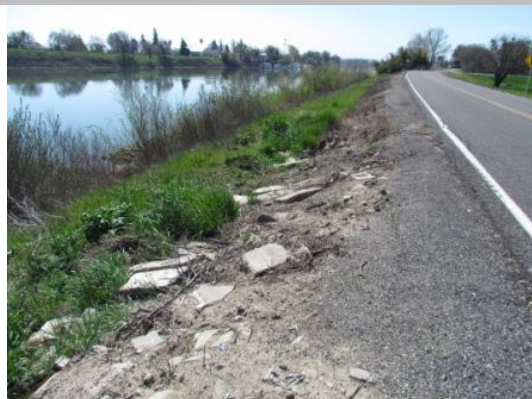
Photo 1 of 1 : FA_2016_RD0150_16_10_20160823_00007.jpg

Debris was found on the waterside slope of the levee looking downstream during Spring 2013 inspection.

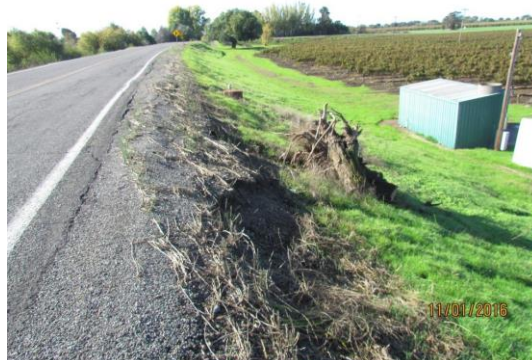
Photo 1 of 2 : FA_2016_RD0150_16_59_20161104_00117.jpg

LM Start	0.71	Rating **	M	Issue No.	59
LM End	0.71	Issue Type +	Ma	Location *	LS
Category	Earthen Levee			GPS Latitude/Longitude	
				Start	End
Item	Encroachments			38.336291 °	38.336291 °
				-121.568260 °	-121.568260 °
DWR ID	DWR_RD0150_02_s_2016_59				
Comment Code					
TR : Tree or limb					
Inspector Comment					
Damaged tree roots and trunks appear to damage landside slope of the levee.

Updated picture of the tree limbs and roots on the landside of the levee looking downstream. Fall 2016

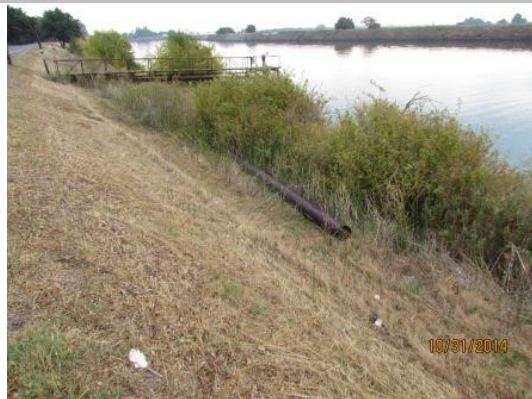
Photo 1 of 1 : FA_2016_RD0150_16_50_20160823_00027.jpg

LM Start	1.89	Rating **	M	Issue No.	50
LM End	1.89	Issue Type +	Ma	Location *	WS
Category	Earthen Levee			GPS Latitude/Longitude	
				Start	End
Item	Encroachments			38.346323 °	38.346323 °
				-121.551568 °	-121.551568 °
DWR ID	DWR_RD0150_02_f_2014_50				
Comment Code					
PI : Pipe					
Inspector Comment					
An abandoned pipe was found on the waterside of the levee.

A pipe was found on the waterside toe of the levee looking upstream.

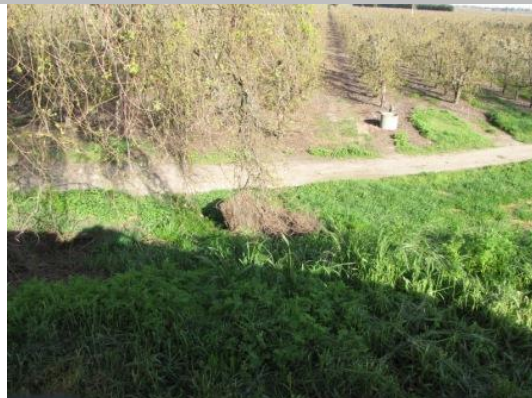
Photo 1 of 1 : FA_2016_RD0150_16_14_20160823_00010.jpg

LM Start	2.75	Rating **	N	Issue No.	14
LM End	2.75	Issue Type +	Ma	Location *	LS
Category	Earthen Levee			GPS Latitude/Longitude	
				Start	End
Item	Trim / Thin Trees			38.350041 °	38.350041 °
				-121.536853 °	-121.536853 °
DWR ID	DWR_RD0150_02_s_2012_14				
Comment Code					
T5 : Tree stumps.					
Inspector Comment

View of a tree stump on the landward slope.

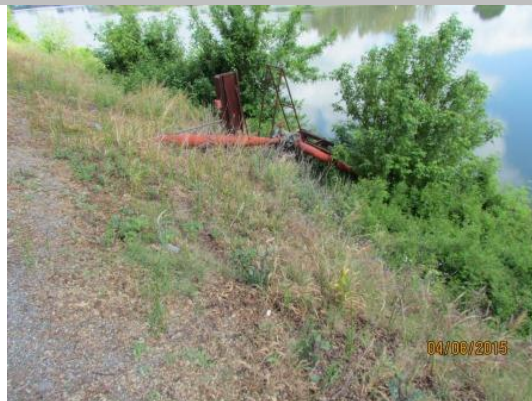
Photo 1 of 5 : FA_2016_RD0150_16_961_20160823_00050.jpg

LM Start	3.24	Rating **	M	Issue No.	961
LM End	3.24	Issue Type +	Ma	Location *	WS
Category	Earthen Levee			GPS Latitude/Longitude	
				Start	End
Item	Erosion / Bank Caving			38.355321°	38.355321°
				-121.530902°	-121.530902°
DWR ID	DWR_RD0150_02_s_2012_961				
Comment Code					
E2 : Schedule repair of erosion site prior to the next inspection.					
Inspector Comment					
Depressions into the waterward slope can be seen along the waterward slope at this site. Also note the damaged pump support, pump, and pipe just upstream of the site; they may contribute to the erosion in a high water event and should be removed.

Updated picture of the erosion on the waterside of the levee during spring 2015 inspection.

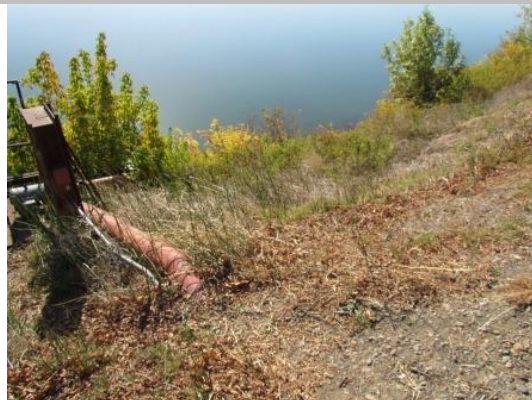
Photo 2 of 5 : FA_2016_RD0150_16_961_20160823_00051.jpg

View of the erosion on the waterside slope of the levee near the pipe looking downstream. This picture was taken during the fall 2013 inspection.

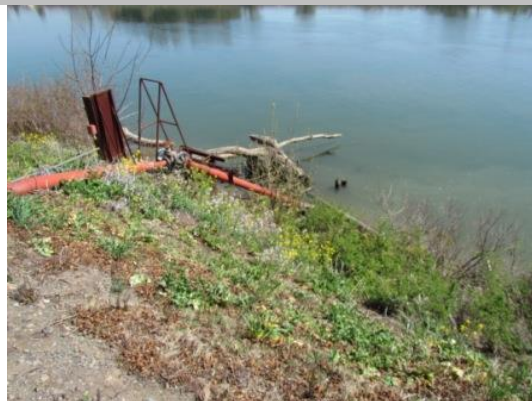
Photo 3 of 5 : FA_2016_RD0150_16_961_20160823_00052.jpg

LM Start	3.24	Rating **	M	Issue No.	961 (cont)
LM End	3.24	Issue Type +	Ma	Location *	WS
Category	Earthen Levee			GPS Latitude/Longitude	
				Start	End
Item	Erosion / Bank Caving			38.355321°	38.355321°
				-121.530902°	-121.530902°
DWR ID	DWR_RD0150_02_s_2012_961				
Comment Code					
E2 : Schedule repair of erosion site prior to the next inspection.					
Inspector Comment					
Depressions into the waterward slope can be seen along the waterward slope at this site. Also note the damaged pump support, pump, and pipe just upstream of the site; they may contribute to the erosion in a high water event and should be removed.

View of the erosion on the waterside slope of the levee looking upstream during spring 2013 inspection.

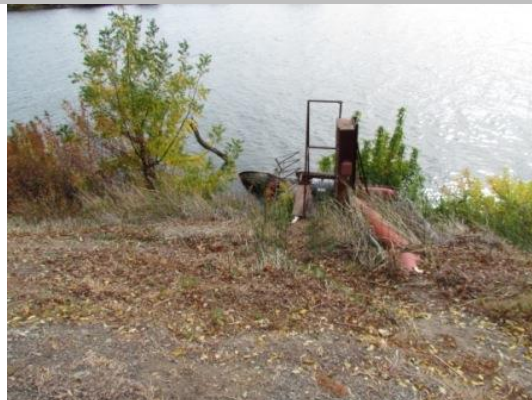
Photo 4 of 5 : FA_2016_RD0150_16_961_20160823_00053.jpg

View of erosion and damaged pipe and abandoned boat on the waterside of the levee looking upstream. This picture was taken during fall 2012 inspection.

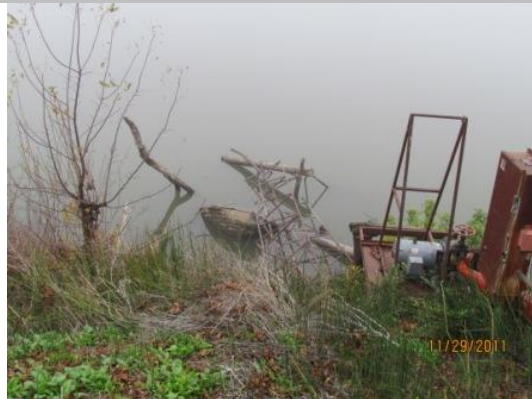
Photo 5 of 5 : FA_2016_RD0150_16_961_20160823_00054.jpg

LM Start	3.24	Rating **	M	Issue No.	961 (cont)
LM End	3.24	Issue Type +	Ma	Location *	WS
Category	Earthen Levee			GPS Latitude/Longitude	
				Start	End
Item	Erosion / Bank Caving			38.355321 °	38.355321 °
				-121.530902 °	-121.530902 °
DWR ID	DWR_RD0150_02_s_2012_961				
Comment Code					
E2 : Schedule repair of erosion site prior to the next inspection.					
Inspector Comment					
Depressions into the waterward slope can be seen along the waterward slope at this site. Also note the damaged pump support, pump, and pipe just upstream of the site; they may contribute to the erosion in a high water event and should be removed.

View of the erosion site, and broken pump support along with a boat on the waterside of the levee. The picture was taken from the crown looking towards the toe of the levee during fall 2011 inspection.

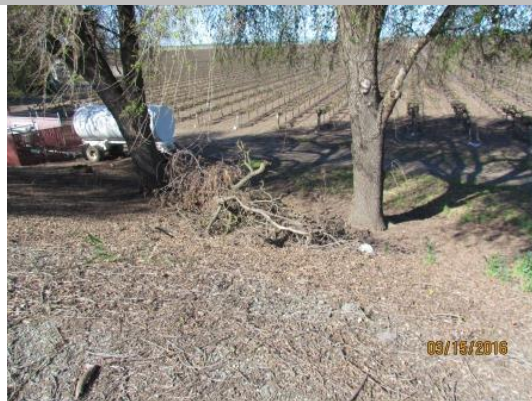
Photo 1 of 1 : FA_2016_RD0150_16_61_20160823_00036.jpg

View of prunings on the landside of the levee.

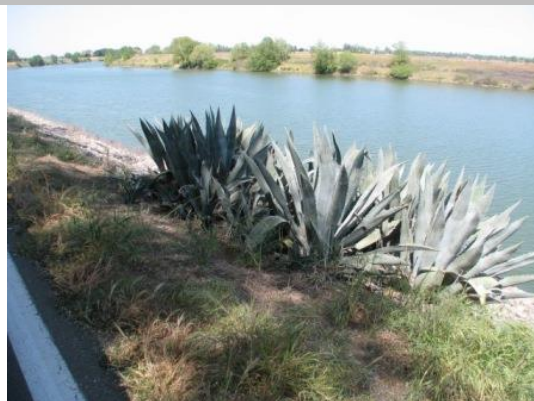
Photo 1 of 1 : FA_2016_RD0150_16_28_20160823_00017.jpg

Century plant on waterward slope at LM 4.76

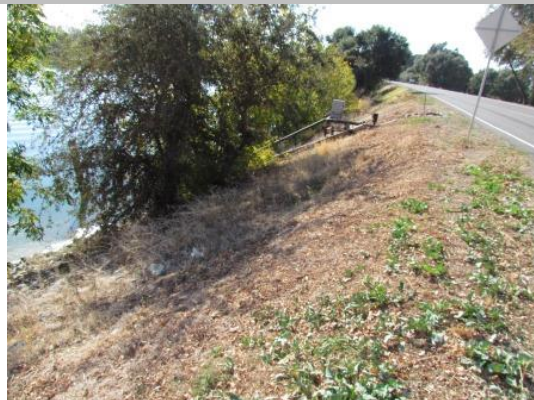
Photo 1 of 2 : FA_2016_RD0150_16_975_20160823_00055.jpg

LM Start	5.24	Rating **	M	Issue No.	975
LM End	5.24	Issue Type +	Ma	Location *	WS
Category	Earthen Levee			GPS Latitude/Longitude	
				Start	End
Item	Slope Stability			38.381126°	38.381126°
				-121.524207°	-121.524207°
DWR ID	DWR_RD0150_02_s_2013_975				
Comment Code					
S1 : Repair slope instability.					
Inspector Comment					
Depression in the waterward slope at the shoulder over an irrigation pipe.

View of minor slope instability on the waterside slope of the levee looking downstream during fall 2013 inspection.

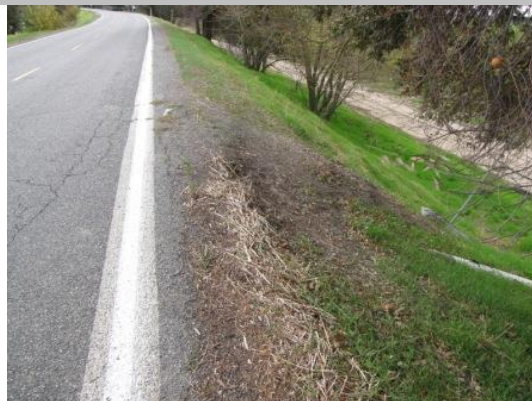
Photo 2 of 2 : FA_2016_RD0150_16_975_20160823_00056.jpg

LM Start	5.24	Rating **	M	Issue No.	975 (cont)	
LM End	5.24	Issue Type +	Ma	Location *	WS	
Category	Earthen Levee			GPS Latitude/Longitude		
				Start		End
Item	Slope Stability			38.381126 °		38.381126 °
				-121.524207 °		-121.524207 °
DWR ID	DWR_RD0150_02_s_2013_975					
Comment Code						
S1 : Repair slope instability.						
Inspector Comment						
Depression in the waterward slope at the shoulder over an irrigation pipe.

View of a minor depression along the landward slope of the levee over a pipe penetration looking downstream.

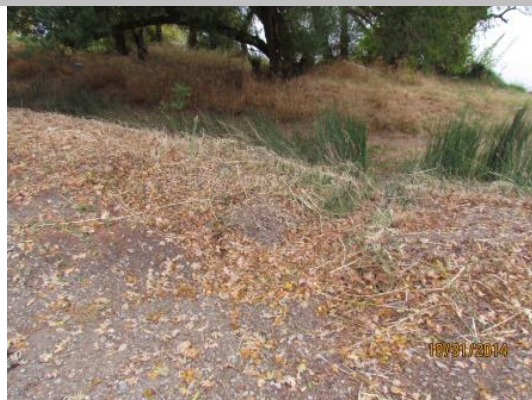
Photo 1 of 1 : FA_2016_RD0150_16_54_20160823_00029.jpg

LM Start	5.33	Rating **	M	Issue No.	54
LM End	5.33	Issue Type +	Ma	Location *	WS
Category	Earthen Levee			GPS Latitude/Longitude	
				Start	End
Item	Slope Stability			38.382072 °	38.382072 °
				-121.523220 °	-121.523220 °
DWR ID	DWR_RD0150_02_f_2014_54				
Comment Code					
S2 : Repair the levee slope damaged by foot traffic and prevent access where possible.					
Inspector Comment

View of a slope instability on the waterside of the levee looking towards the toe.

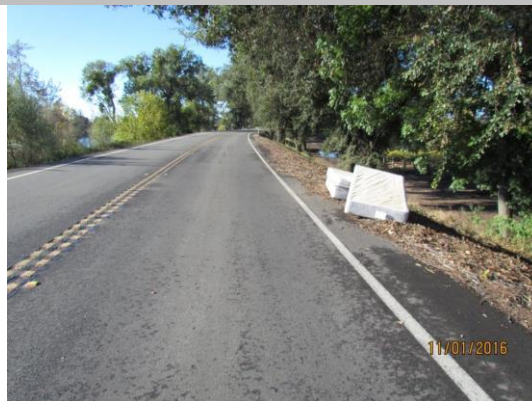
Photo 1 of 1 : FA_2016_RD0150_16_62_20161104_00115.jpg

View of debris on the landside shoulder of the levee. Fall 2016

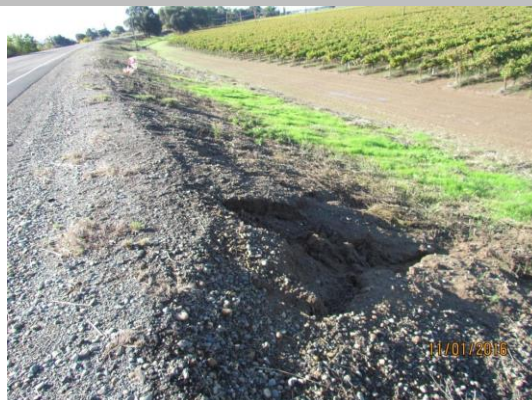
Photo 1 of 1 : FA_2016_RD0150_16_52_20161104_00114.jpg

LM Start	5.90	Rating **	M	Issue No.	52
LM End	5.90	Issue Type +	Ma	Location *	LS
Category	Earthen Levee			GPS Latitude/Longitude	
				Start	End
Item	Erosion / Bank Caving			38.387915 °	38.387915 °
				-121.516002 °	-121.516002 °
DWR ID	DWR_RD0150_02_f_2016_52				
Comment Code					
E2 : Schedule repair of erosion site prior to the next inspection.					
Inspector Comment					
Erosion due to runoff.

View of an erosion due to runoff on the landside of the levee. Fall 2016

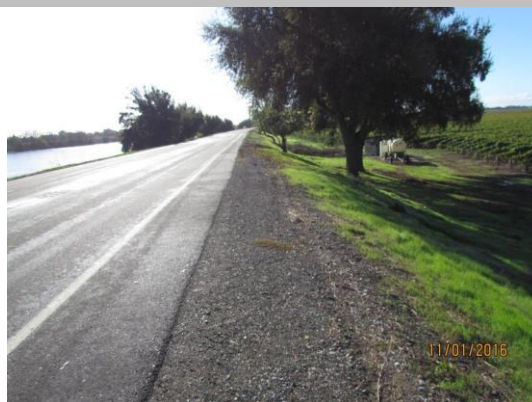
Photo 1 of 1 : FA_2016_RD0150_16_51_20161104_00113.jpg

View of landside slope of the levee. Fall 2016

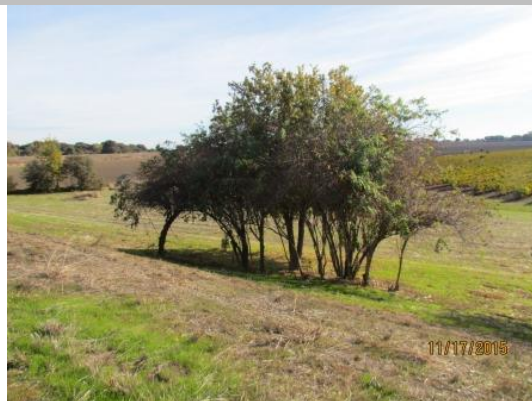
Photo 1 of 1 : FA_2016_RD0150_17_5_20160823_00005.jpg

View of elderberries on the landward slope of the levee.

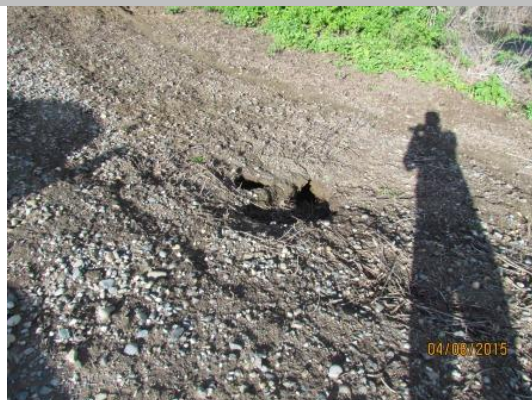
Photo 1 of 1 : FA_2016_RD0150_17_393_20160823_00095.jpg

Rodent holes were found on the waterside of the levee looking downstream.

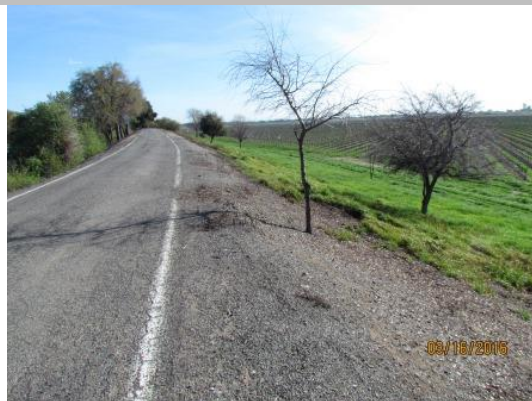
Photo 1 of 1 : FA_2016_RD0150_17_75_20160823_00066.jpg

LM Start	2.24	Rating **	M	Issue No.	75
LM End	2.24	Issue Type +	Ma	Location *	LS
Category	Earthen Levee			GPS Latitude/Longitude	
				Start	End
Item	Vegetation			38.353811 °	38.353811 °
				-121.565668 °	-121.565668 °
DWR ID	DWR_RD0150_03_f_2014_75				
Comment Code					
V2 : Remove the wild growth other than native grasses from the levee slopes.					
Inspector Comment					
Newly planted tree was found on the landside slope of the levee.

Updated picture of the newly planted tree on the landside shoulder of the levee during spring 2016.

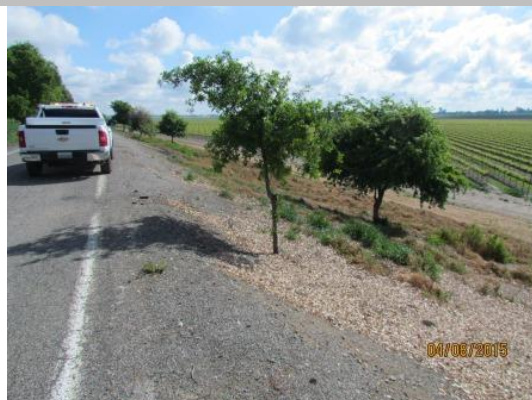
Photo 1 of 4 : FA_2016_RD0150_17_78_20160823_00069.jpg

Updated picture of the trees on the landside of the levee during spring 2015 inspection.

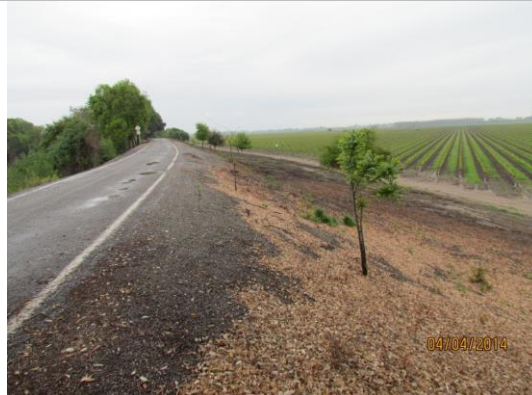
Photo 2 of 4 : FA_2016_RD0150_17_78_20160823_00070.jpg

View of the newly planted tree on the landside slope of the levee during spring 2014 inspection.

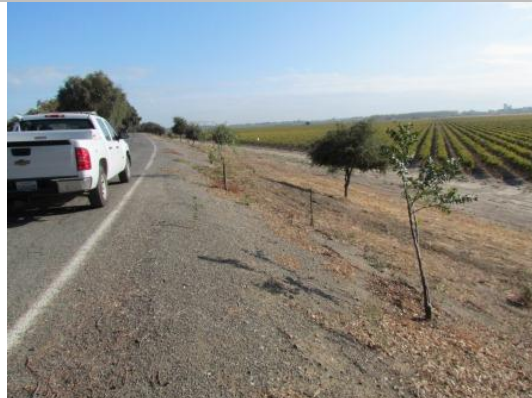
Photo 3 of 4 : FA_2016_RD0150_17_78_20160823_00071.jpg

Several newly planted trees were found on the landside slope of the levee looking upstream during the fall 2013 inspection.

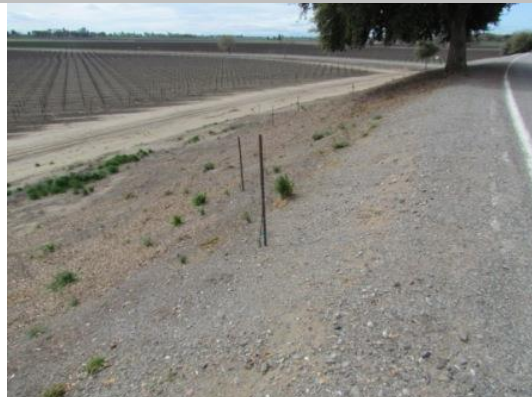
Photo 4 of 4 : FA_2016_RD0150_17_78_20160823_00072.jpg

New tree was planted on the landside of the levee looking downstream.

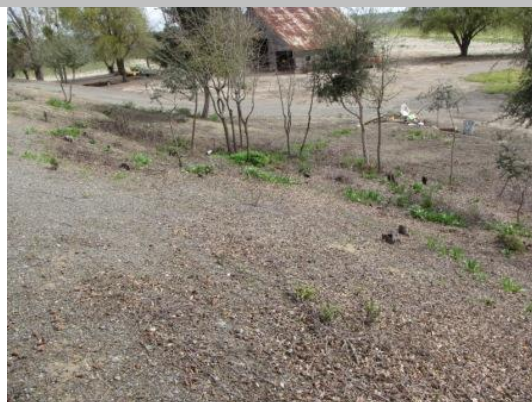
Photo 1 of 1 : FA_2016_RD0150_17_11_20160823_00008.jpg

View of tree stumps on the landward slope.

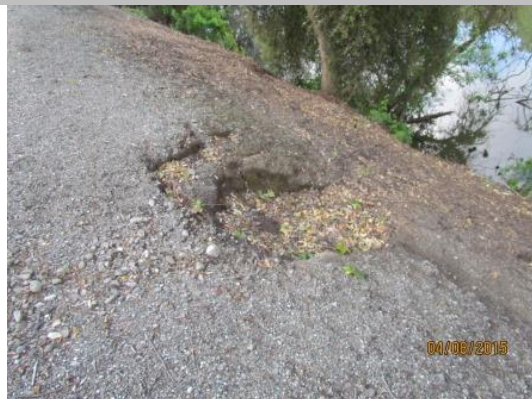
Photo 1 of 2 : FA_2016_RD0150_17_35_20160823_00028.jpg

LM Start	2.80	Rating **	M	Issue No.	35
LM End	2.80	Issue Type +	Ma	Location *	WS
Category	Earthen Levee			GPS Latitude/Longitude	
				Start	End
Item	Erosion / Bank Caving			38.360432 °	38.360432 °
				-121.561644 °	-121.561644 °
DWR ID	DWR_RD0150_03_s_2013_35				
Comment Code					
E2 : Schedule repair of erosion site prior to the next inspection.					
Inspector Comment

Updated picture of the erosion on the waterside of the levee during spring 2015 inspection.

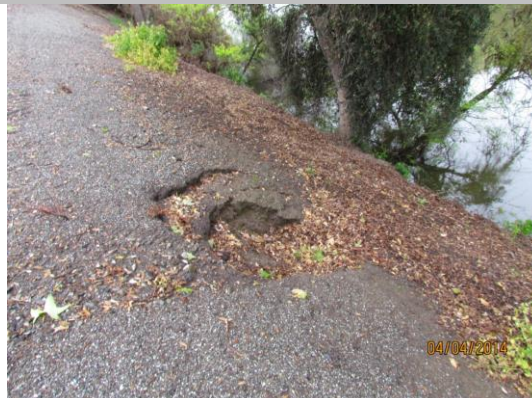
Photo 2 of 2 : FA_2016_RD0150_17_35_20160823_00029.jpg

Updated picture of the erosion on the waterside slope of the levee during spring 2014 inspection.

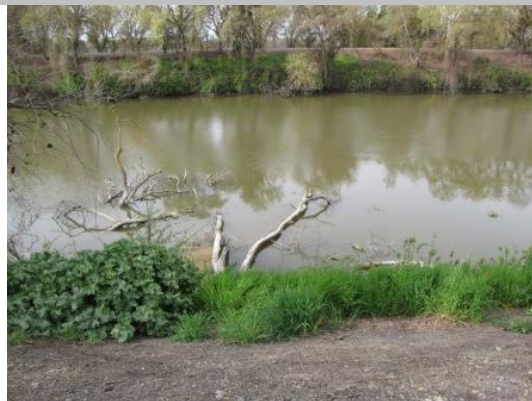
Photo 1 of 1 : FA_2016_RD0150_17_17_20160823_00015.jpg

View of tree stumps on the waterward slope.

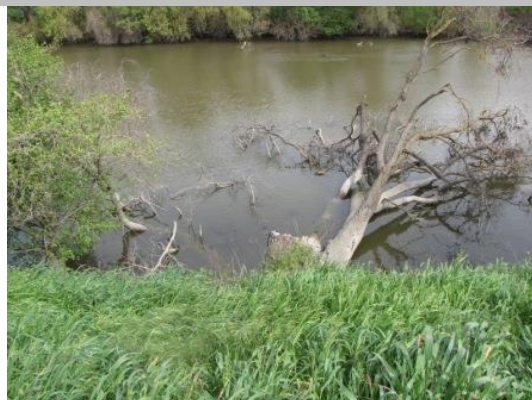
Photo 1 of 1 : FA_2016_RD0150_17_20_20160823_00016.jpg

View of tree stumps on the waterward slope.

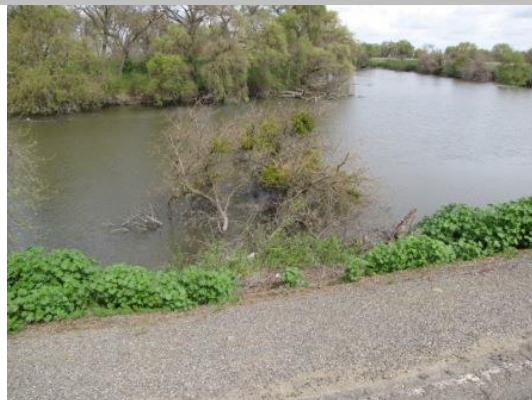
Photo 1 of 1 : FA_2016_RD0150_17_27_20160823_00020.jpg

View of tree stumps on the waterside slope looking upstream.

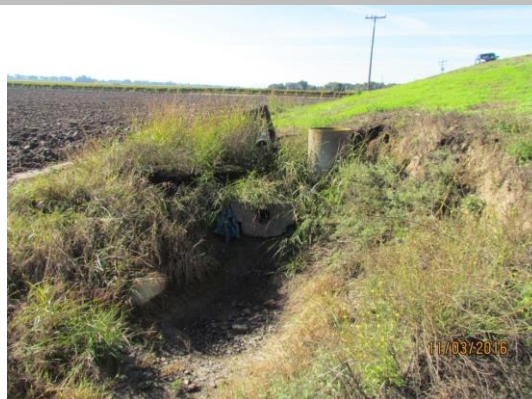
Photo 1 of 3 : FA_2016_RD0150_17_115_20161104_00145.jpg

LM Start	3.39	Rating **	U	Issue No.	115
LM End	3.39	Issue Type +	Ma	Location *	LS
Category	Earthen Levee			GPS Latitude/Longitude	
				Start	End
Item	Erosion / Bank Caving			38.363540 °	38.363540 °
				-121.555554 °	-121.555554 °
DWR ID	DWR_RD0150_03_f_2013_115				
Comment Code					
E2 : Schedule repair of erosion site prior to the next inspection.					
Inspector Comment					
Erosion (ditch) was found on the landside toe of the levee.

Updated picture of the ditch on the landside toe of the levee. Fall 2016

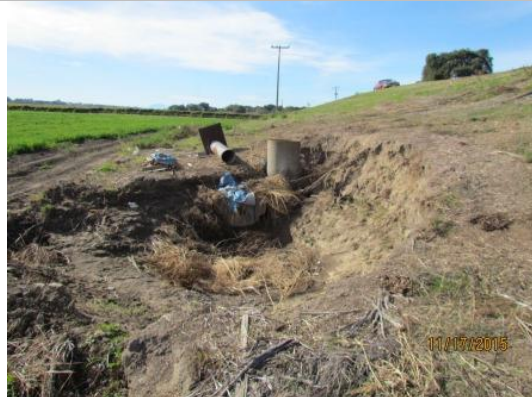
Photo 2 of 3 : FA_2016_RD0150_17_115_20160823_00093.jpg

Updated picture of the ditch on the landside toe of the levee during fall 2015 inspection.

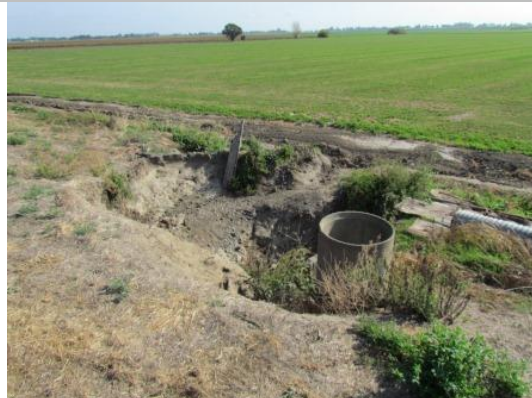
Photo 3 of 3 : FA_2016_RD0150_17_115_20160823_00094.jpg

A drainage ditch with depth of 4 feet and width of 15 feet was found on the landside toe of the levee. The picture was taken from the landside slope looking upstream during the fall 2013 inspection.

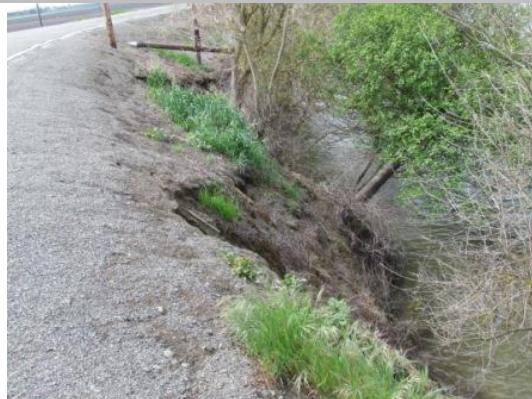
Photo 1 of 1 : FA_2016_RD0150_17_98_20160823_00090.jpg

Erosion was found on the waterside of the levee looking downstream.

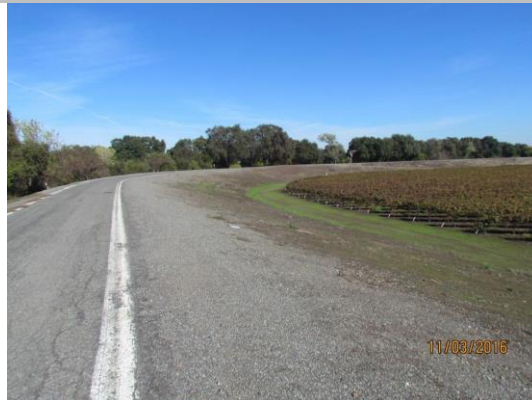
Photo 1 of 1 : FA 2016 RD0150 17 71 20161104 00146.jpg

View of the landside of the levee looking upstream. Fall 2016

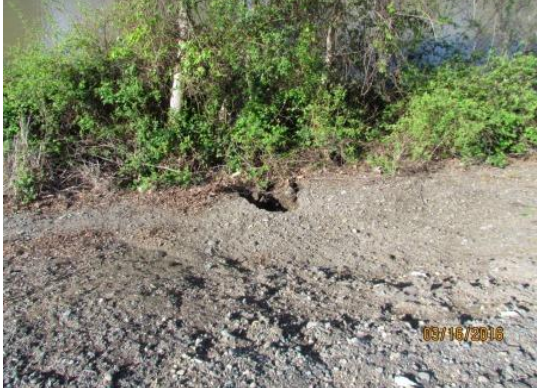
Photo 1 of 1 : FA_2016_RD0150_17_93_20160823_00086.jpg

An erosion was found on the waterside toe of the levee.

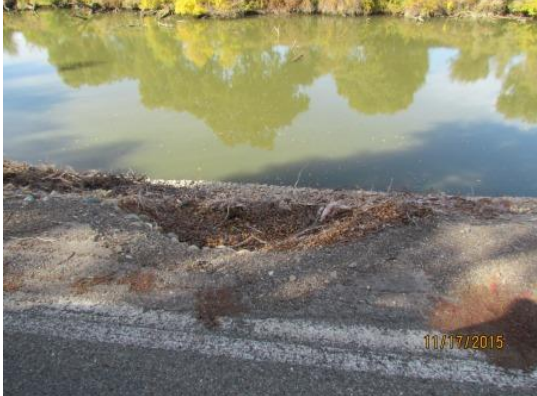
Photo 1 of 2 : FA_2016_RD0150_17_36_20160823_00030.jpg

Updated picture of the slope instability of the waterside shoulder of the levee during fall 2015 inspection.

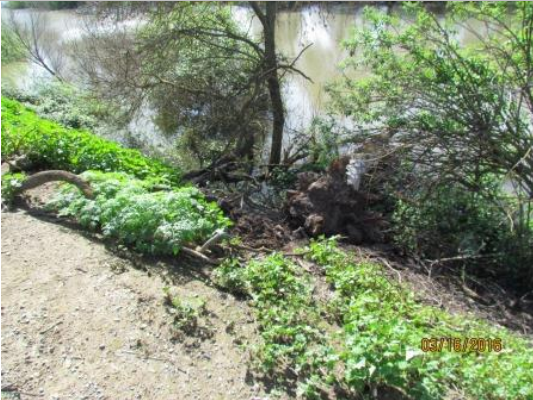
Photo 1 of 1 : FA_2016_RD0150_17_96_20160823_00088.jpg

Broken tree roots and tree trunks were found on the waterside toe of the levee.

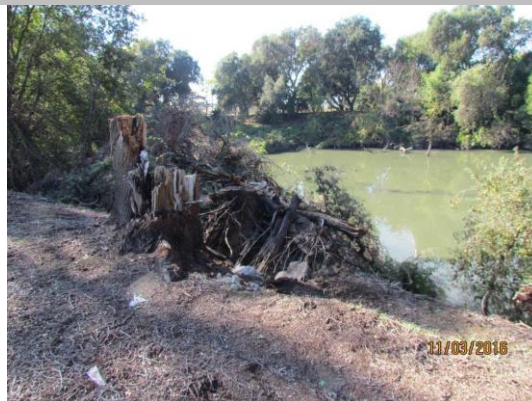
Photo 1 of 1 : FA_2016_RD0150_17_74_20161104_00150.jpg

View of tree trunks on the waterside shoulder of the levee. Fall 2016

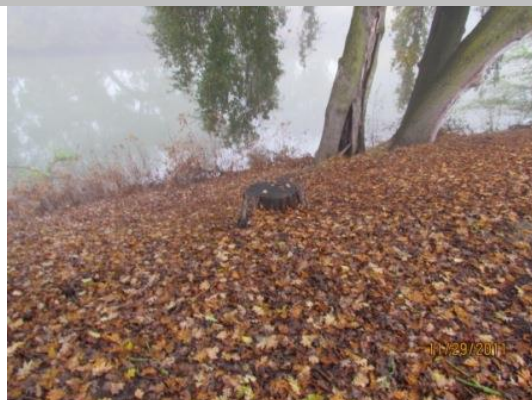
Photo 1 of 1 : FA_2016_RD0150_17_68_20160823_00064.jpg

Tree stump was found on the waterside of the levee looking upstream.

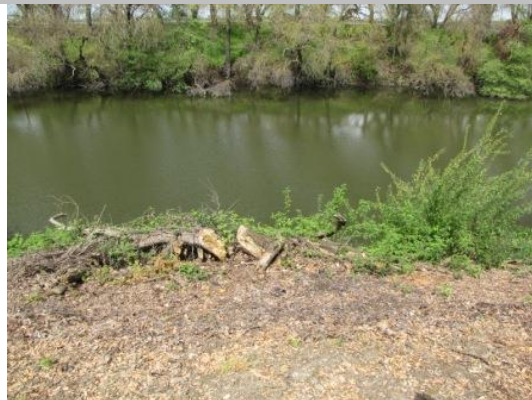
Photo 1 of 1 : FA_2016_RD0150_17_49_20160823_00040.jpg

View of tree stumps on the waterward slope.

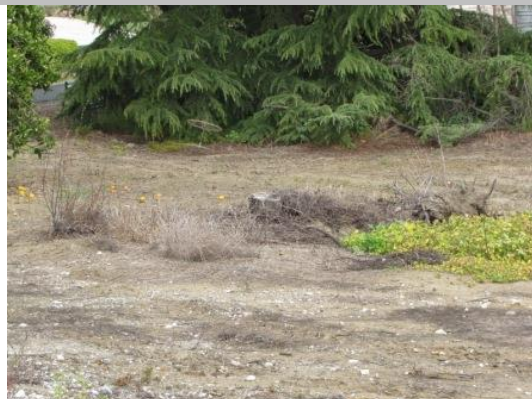
Photo 1 of 1 : FA_2016_RD0150_17_63_20160823_00058.jpg

View of a tree stump on the landward slope.

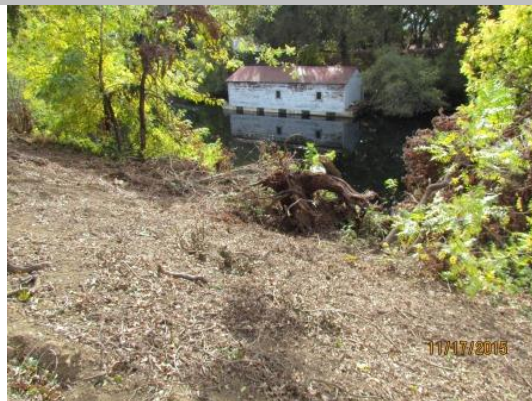
Photo 1 of 1 : FA_2016_RD0150_17_52_20160823_00046.jpg

View of the tree trunk on the waterside toe of the levee.

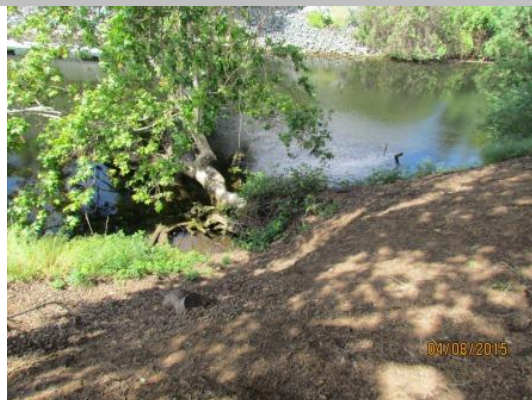
Photo 1 of 1 : FA_2016_RD0150_17_396_20160823_00096.jpg

Slope instability was found on the waterside toe of the levee looking upstream.

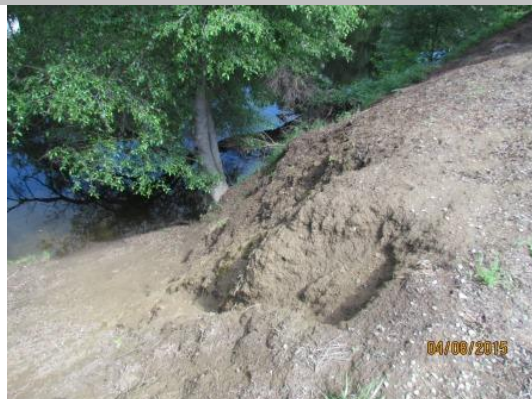
Photo 1 of 2 : FA_2016_RD0150_17_92_20160823_00084.jpg

Updated picture of the slope instability on the waterside of the levee looking upstream during spring 2015 inspection.

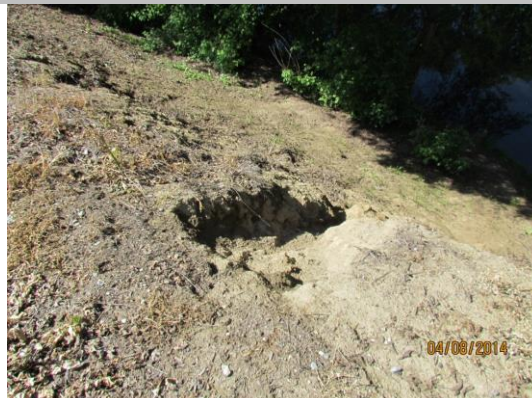
Photo 2 of 2 : FA_2016_RD0150_17_92_20160823_00085.jpg

A slope instability was found on the waterside of the levee looking downstream.

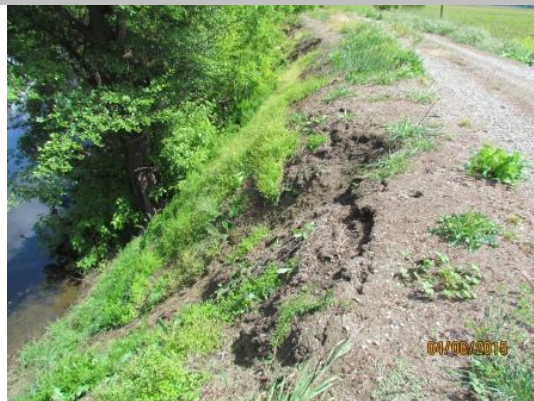
Photo 1 of 1 : FA_2016_RD0150_17_66_20160823_00061.jpg

Updated picture of the erosion on the waterside of the levee.

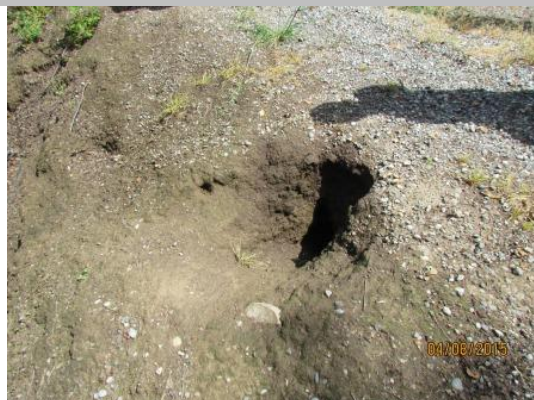
Photo 1 of 2 : FA_2016_RD0150_17_89_20160823_00081.jpg

Updated picture of a rodent hole on the waterside shoulder of the levee during spring 2015 inspection.

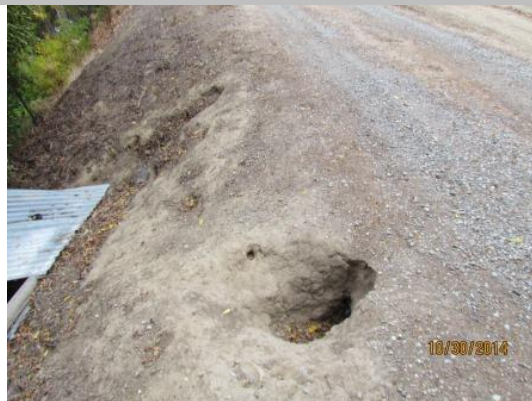
Photo 2 of 2 : FA_2016_RD0150_17_89_20160823_00082.jpg

Updated picture of a rodent hole on the waterside shoulder of the levee during fall 2014 inspection.

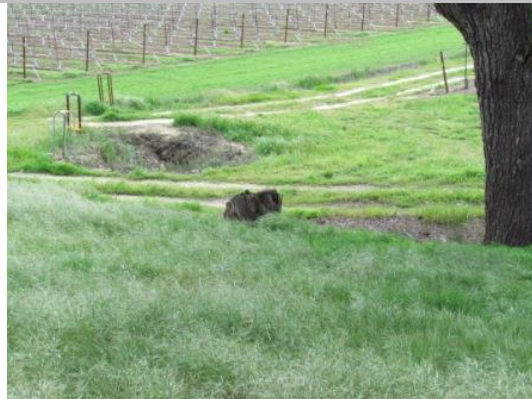
Photo 1 of 1 : FA_2016_RD0150_17_90_20160823_00083.jpg

A tree stump was found on the landside of the levee looking upstream.

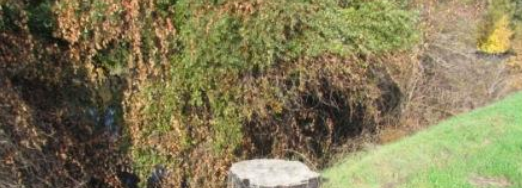
Photo 1 of 1 : FA_2016_RD0150_17_55_20160823_00048.jpg

A tree stump was found on the waterside of the levee looking upstream.
